SFRA Test Report

| Sr. No. | Item | | Details | | |
|---|---|---|---|--|--|
| 3 | | Type | Three Phase Auto-transformer | | |
| | | MVA | 315 | | |

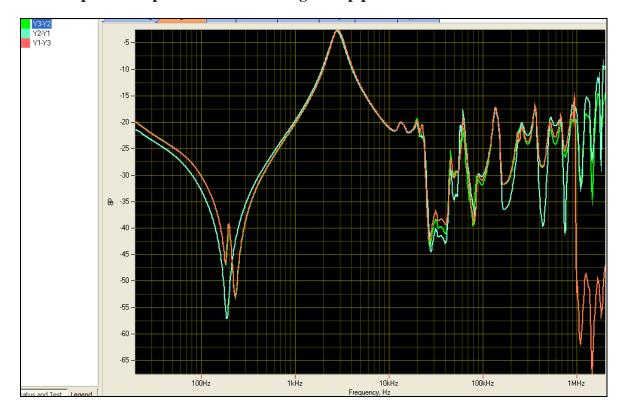
Phase to phase comparison of LV windings at tap position 1.

The difference in pattern observed at high frequency region (above 1 MHz) for Y1Y3 graph w. r. t the adjacent phases, is due to poor contacts, as this matches well with adjacent phases until 1 MHz.
